Man Kam Tong v Man Lin Tai

■ Part 3 Aerial photo applications

Cases in this presentation

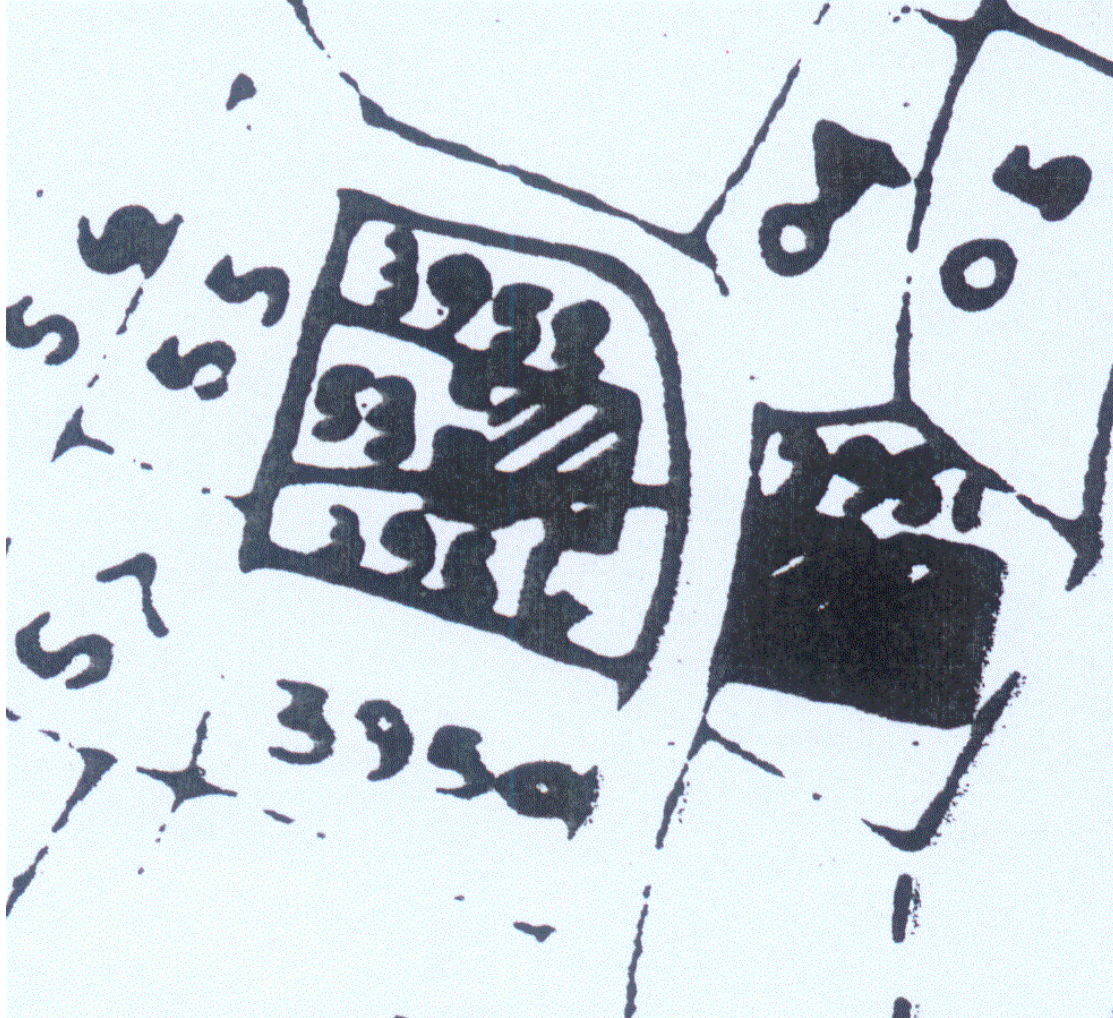
DD Sheet *(enlarged image)*

Defendant's lots not found on land records

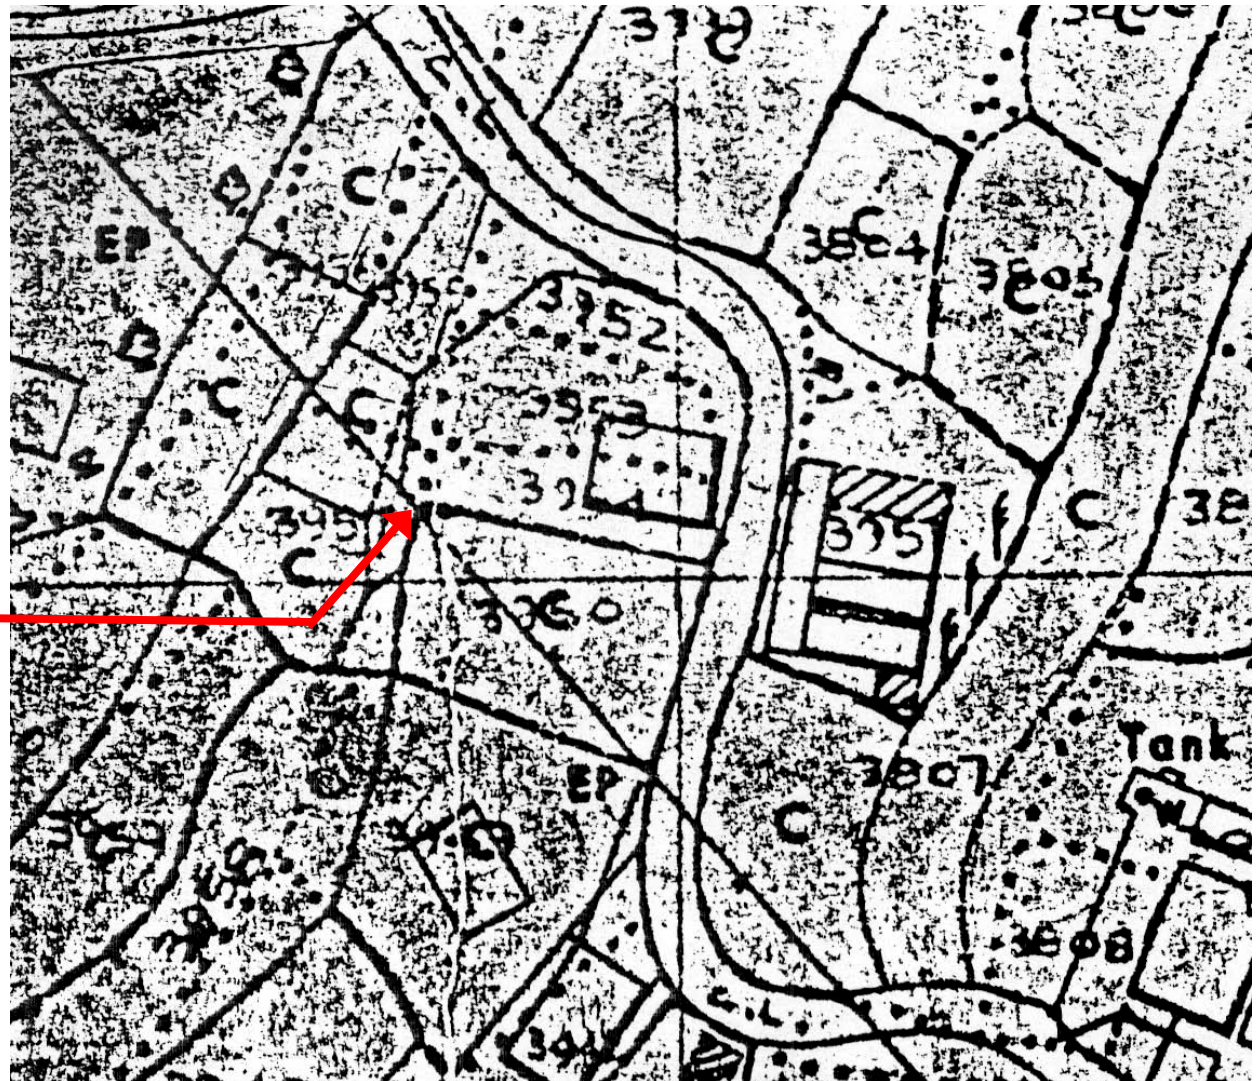
A Sheet (Cad/Svy Sheet)

DD104
Lot 3953
&
Lot 3954

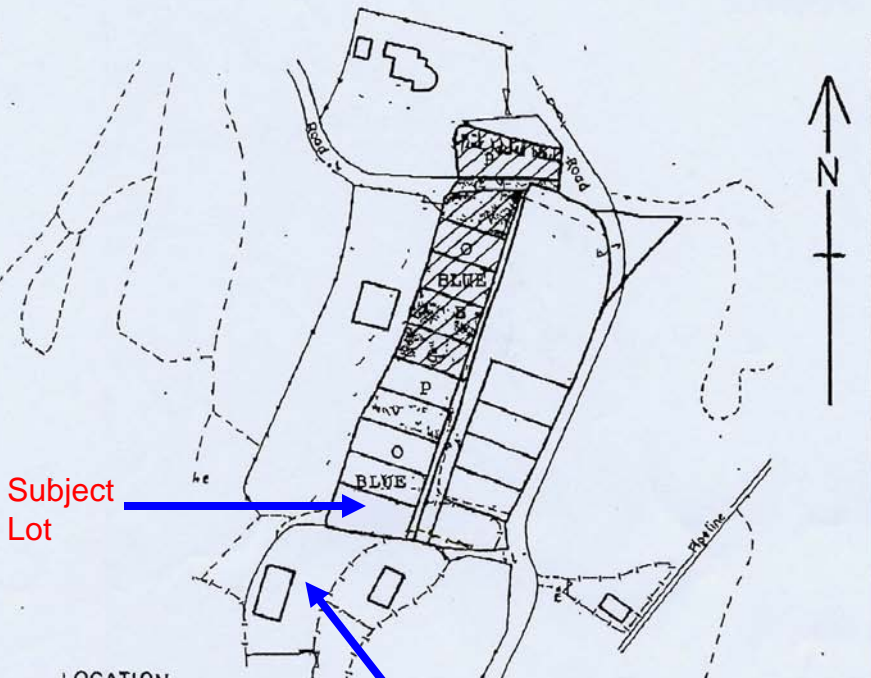
DIVISION PLAN

D.D. 112

Subdivision	Area	Class	Cr. Rent	Owner's Name
371 A1	190m ²	1st	15¢	
371 A2	124m ²	1st	12¢	
371 A3	108m ²	1st	9¢	
371 A4	106m ²	1st	9¢	
371 A5	114m ²	1st	9¢	
371 A6	113m ²	1st	9¢	
371 A7	108m ²	1st	9¢	
371 A8	117.5m ²	1st	9¢	
371 A9	121.4m ²	1st	9¢	
371 A10	121.4m ²	1st	9¢	
371 A11	137m ²	1st	12¢	
371 ARP	217.92m ²	1st	18¢

The boundary of the division plan was incorrect and the registered area of the subject lot is wrong

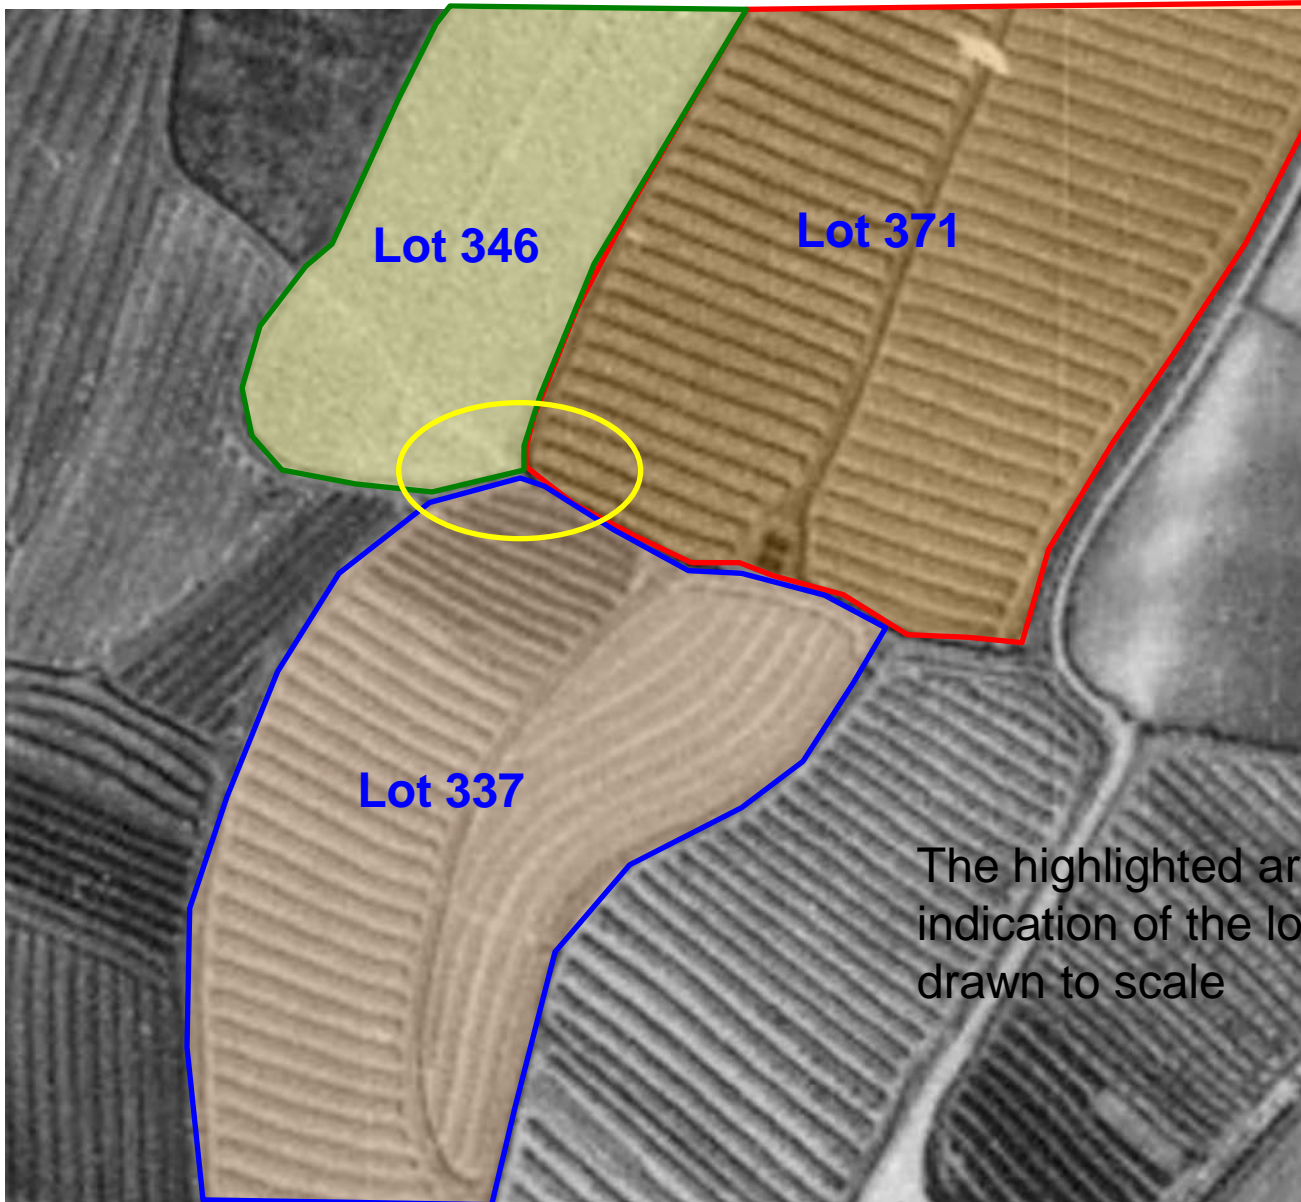
1979 survey sheet

The highlighted area is just for indication of the lots. Not drawn to scale

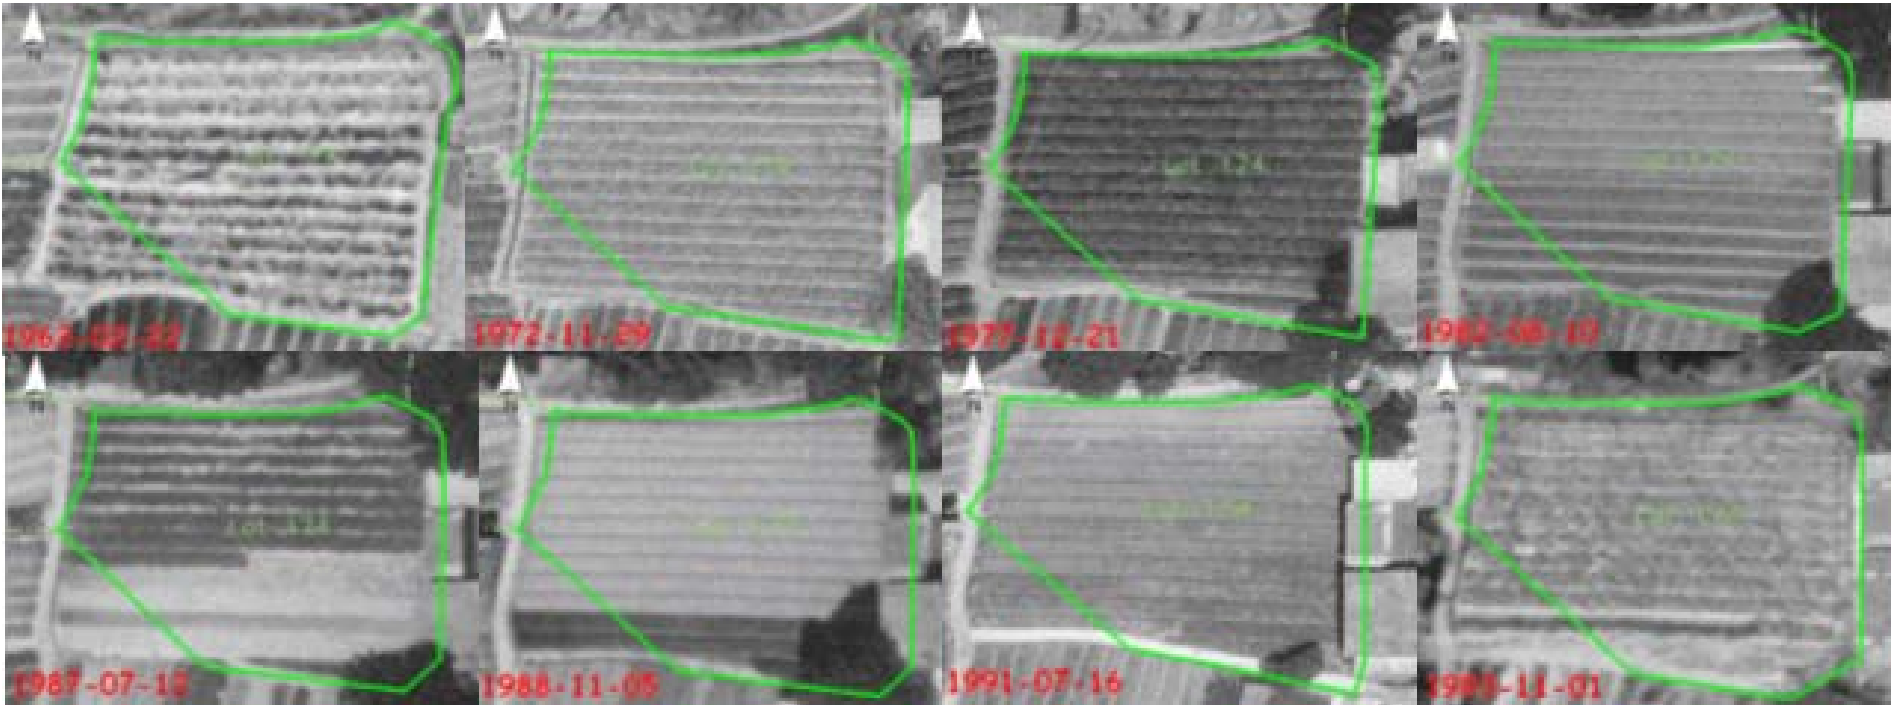
(Ref No. 9974, 2659, 16694, 20511, A15530, A26163, CN5038)

Farming from 1963 - 1995

- Row crops – furrows identified
 - 1963 1972 1977 1982
 - 1987 1988 1991 1993

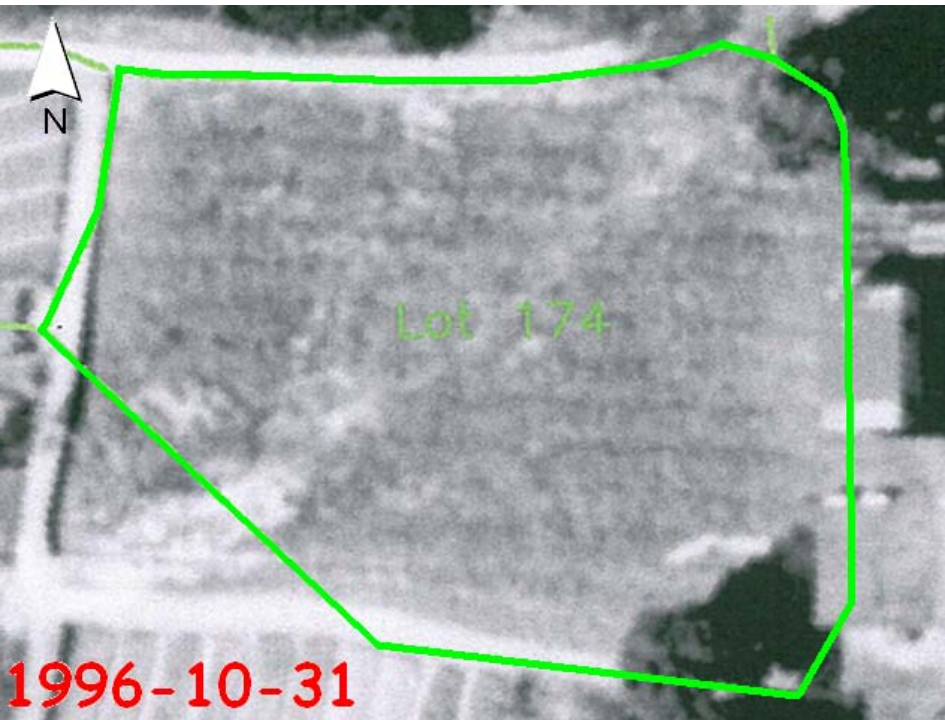
(Ref No. CN15332)

- 1996 - illegibility of row crops
- 1999 - Overgrown vegetation

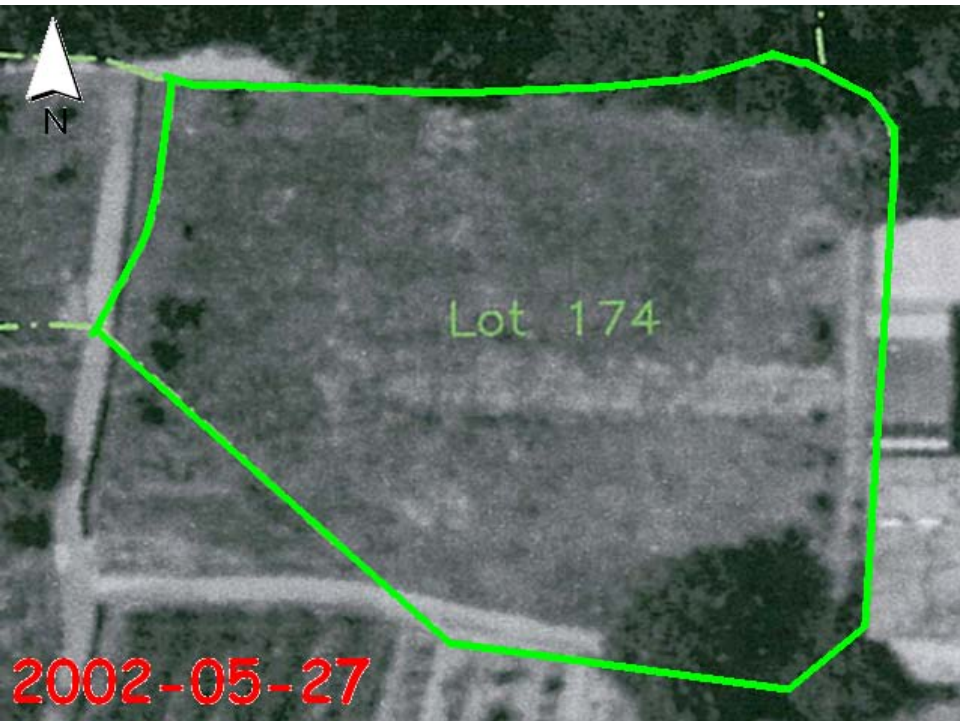
(Ref. No. CW41430)

- 2002 Bare ground
- 2003 Overgrown vegetation extend

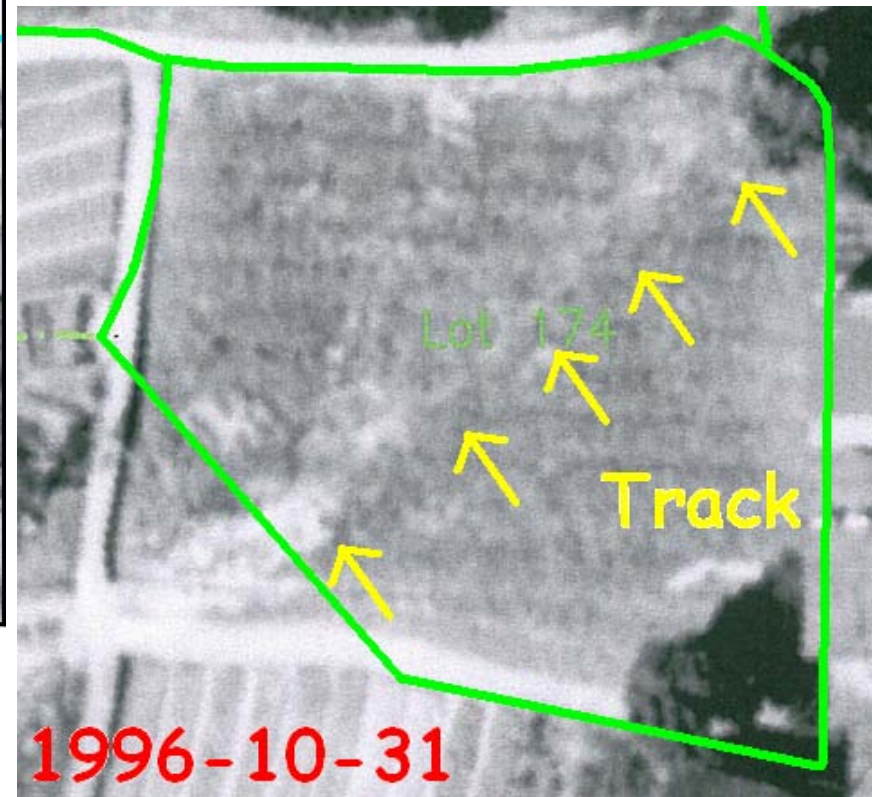
(Ref.No.CN15332)

- Both SC & Helen agreed: Caused by heavy vehicle

Route of heavy vehicles

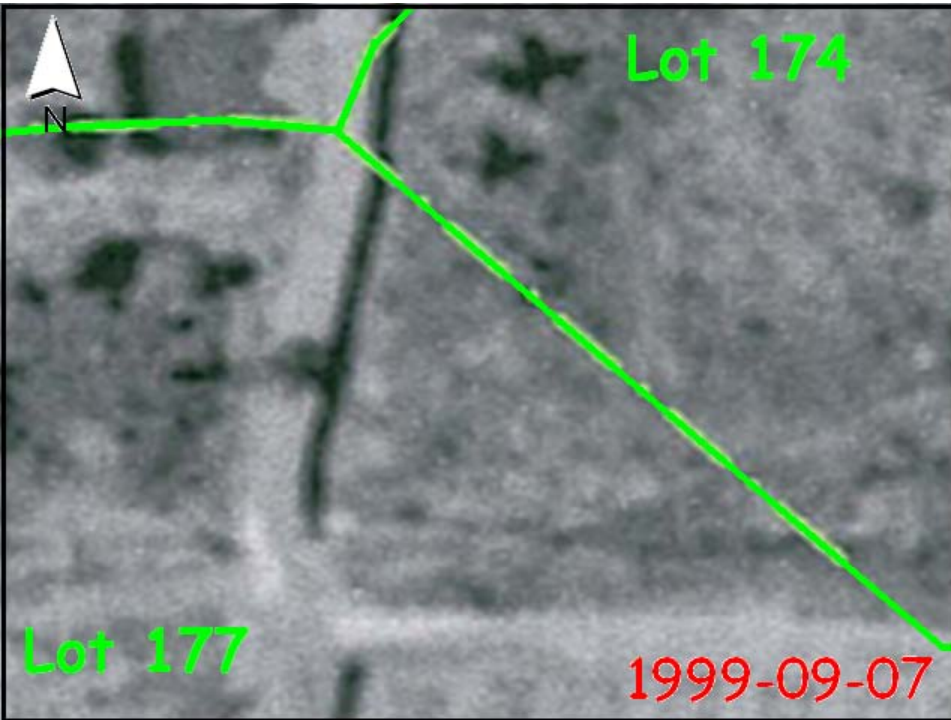
(Ref.No.A49259)

- Helen: Wire-Fence in 2002,2003 visible !

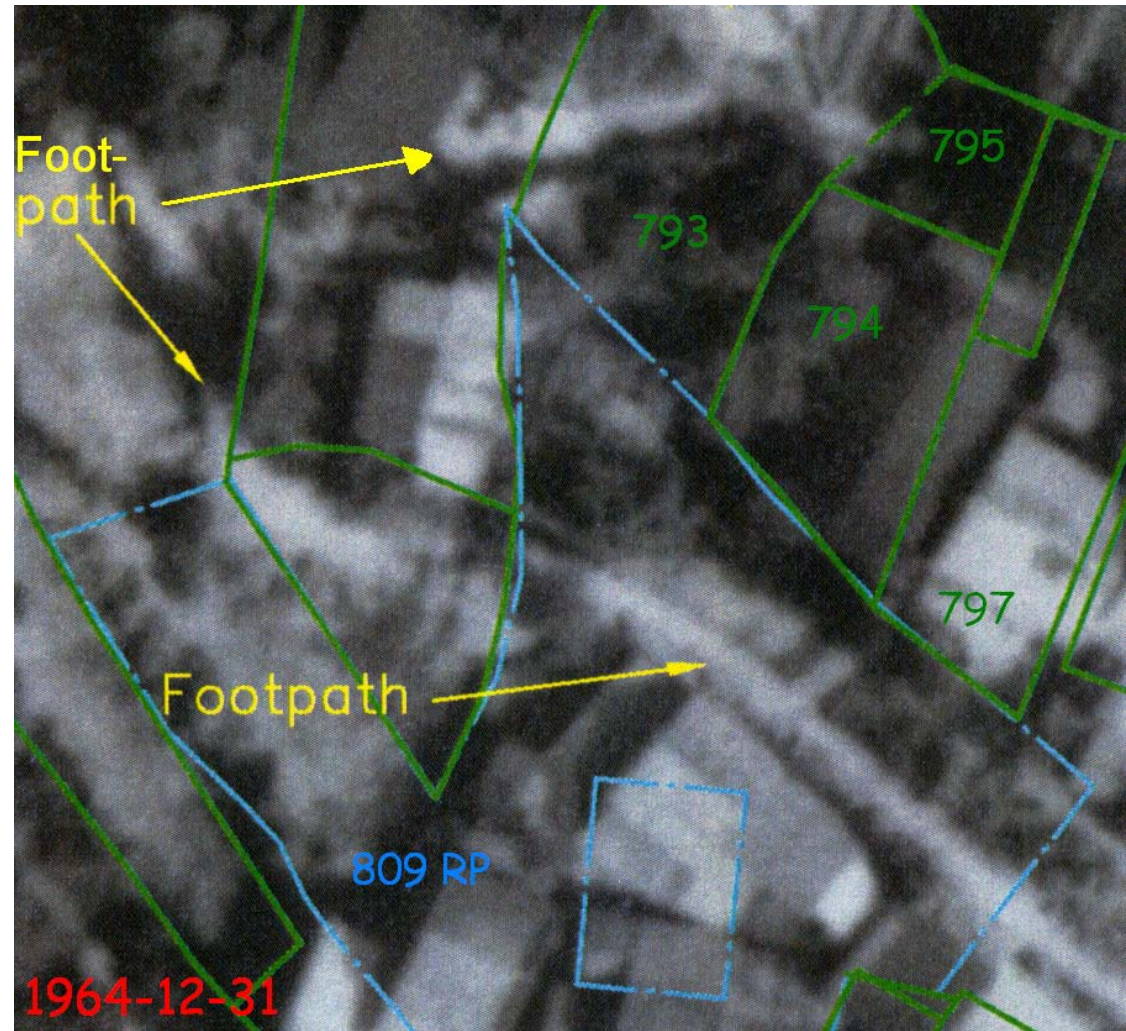
(Ref.No.5344)

- Helen for P
 - 1963, 1964, 1967, 1972, 1976, 1980, 1981, 1982, 1985, 1990, 1995, 2000, 2004, 2005
 - Wire-fences were erected along the footpaths
 - enclosed some temporary structures with some bare land

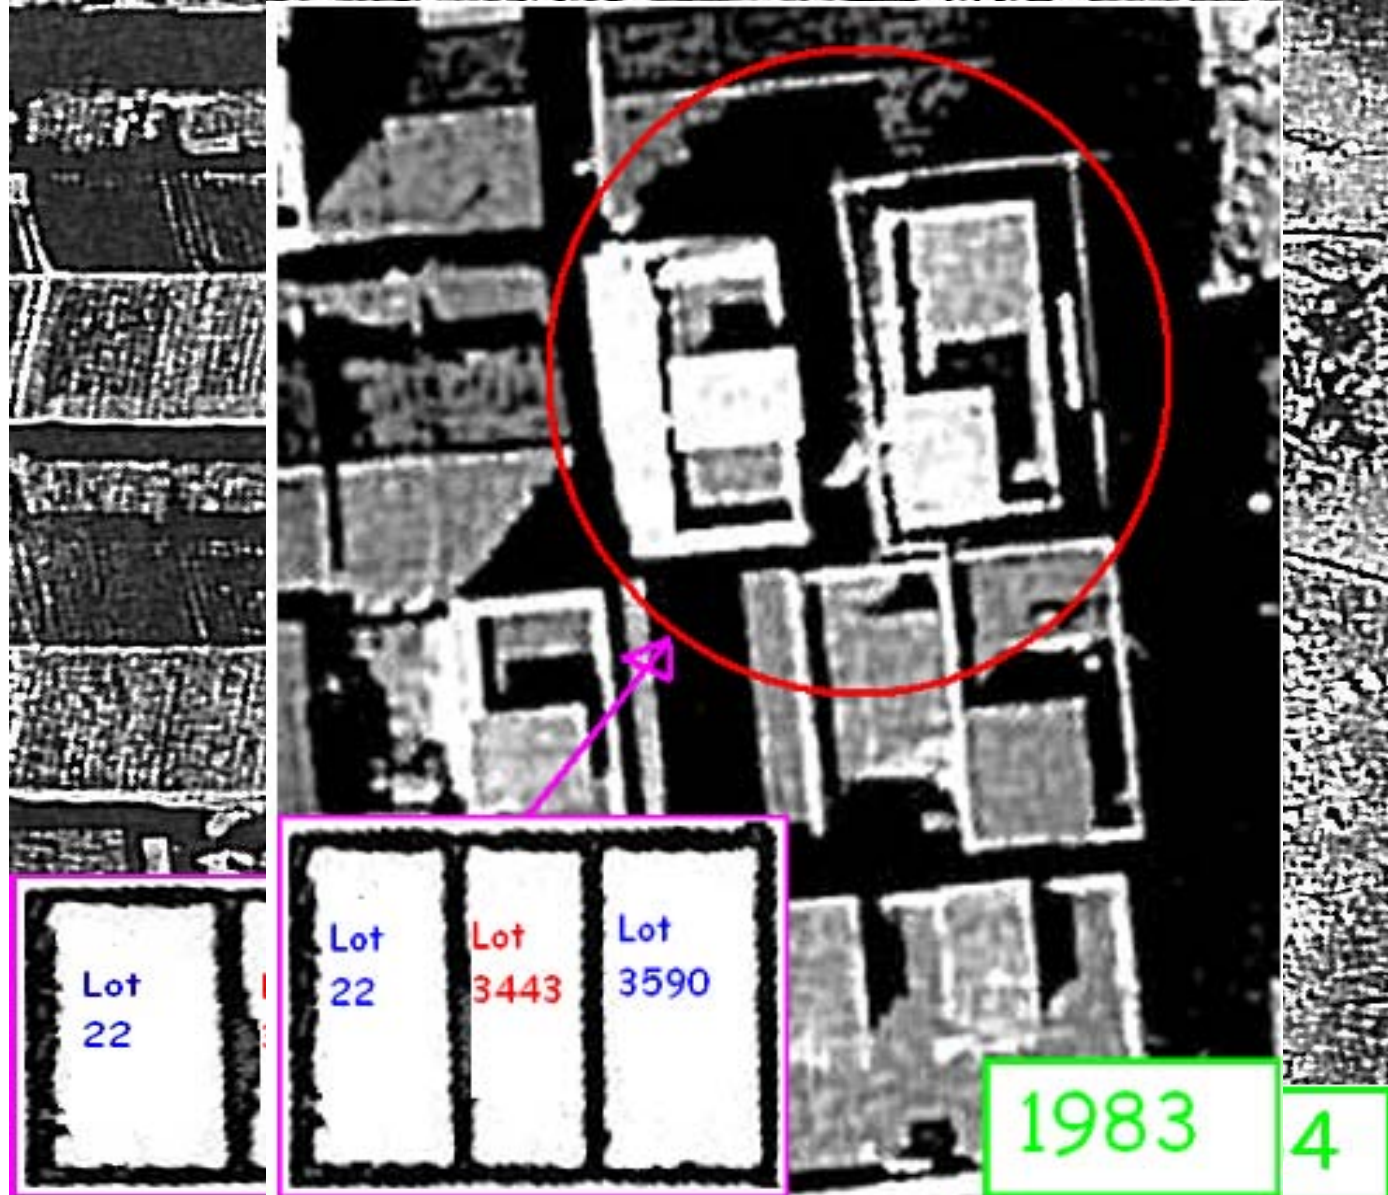
Houses on 1964 & 1983 photos

- 1964-Single Storey traditional Village House

- 1983- 3 storey house

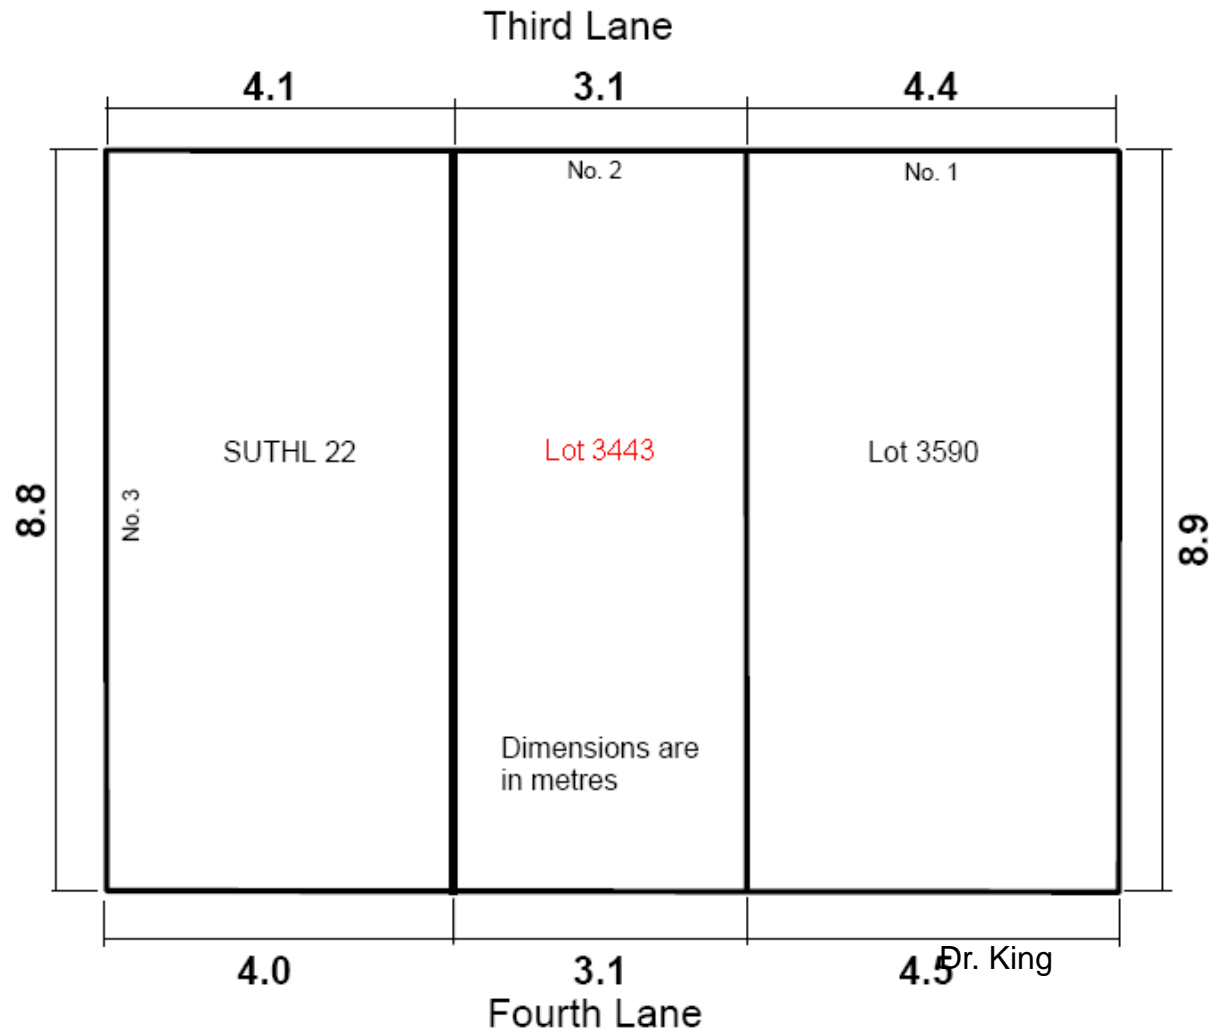
Dr. King's measurement

- Dimension Plan
- Front dimension
→ 4.4m
- Present encroachment
→ 4.396m

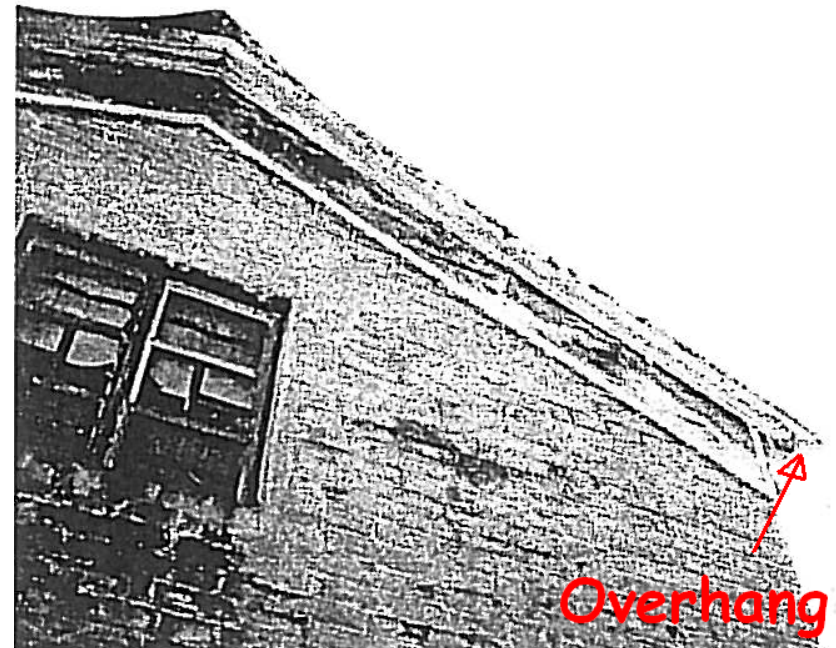
Overhang Structures

- Problems of Stereoscopic measurement
 - RMSE
 - Image Quality
 - Accumulated error
 - overhanging structure

- Court of first Instance
→ sufficiently insignificant
- Court of Appeal
→ No firm conclusion
- Court of Final Appeal
→ No basic assumption
→ Absence of evidence
