Surveying & Built Environment

THE HONG KONG INSTITUTE OF SURVEYORS

Repeated Planning Applications by Developers under Statutory Zoning:
 a Technical Note on Delays in Private Residential Development Process

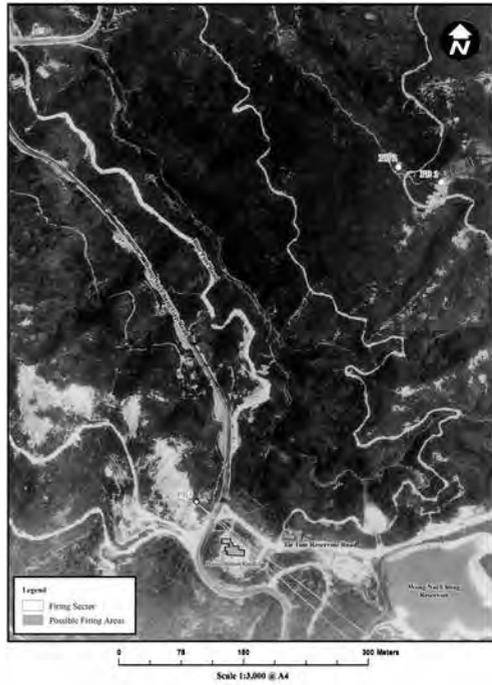
Figure 1a: Horizontal cone showing only possible firing position zones for rear wall hit marks.

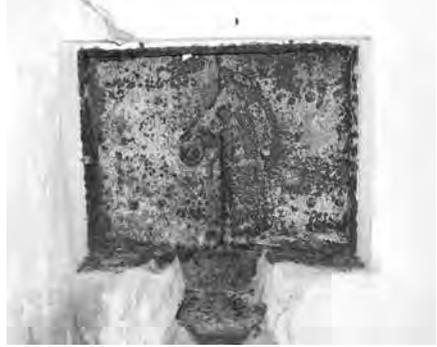
Fig 2: The undamaged interior of a Hong Kong Island pillbox never engaged in any fighting.

Kong Island that were not attacked for it to be very questionable, whether any battle damage was incurred (**Figure 2**). The apparent degradation of the gun mount could be due to rust and other corrosion over the intervening 70 years. The gun mount of the pillbox in Tai Tam Gap (**Figure 2**) was also “damaged” in a similar manner, but there is no record of a struggle for this pillbox.

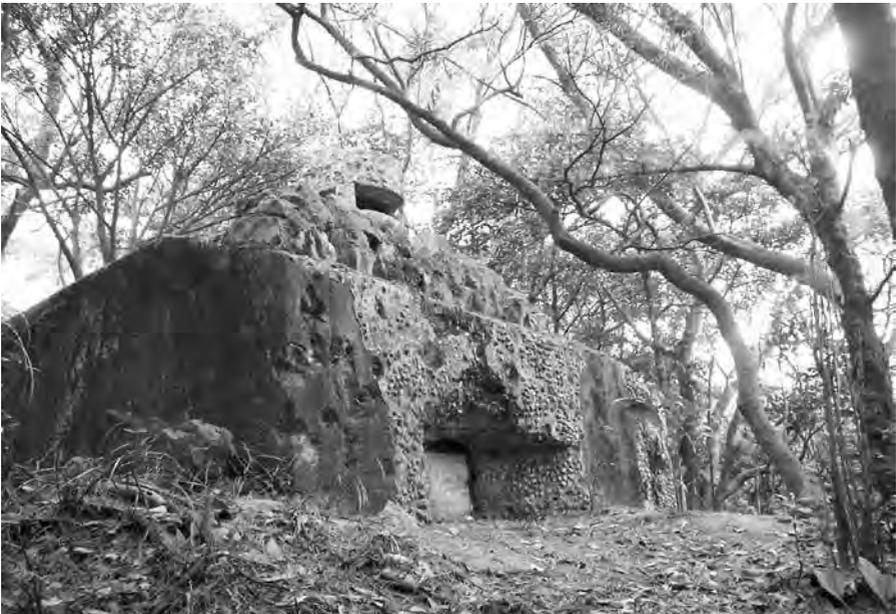
Fig 3: The heavily bullet scarred exterior of PBI after a fierce engagement during the early phases of the Battle for Wong Nai Chung Gap.

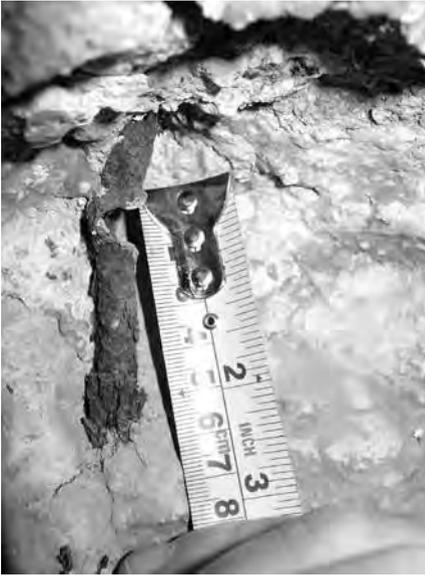
Fig 4: The almost severed reinforcement bar in the interior hit mark area. Note dimension c.6.5mm – the same as Japanese Model 96 LMG and Model 38 Rifle.

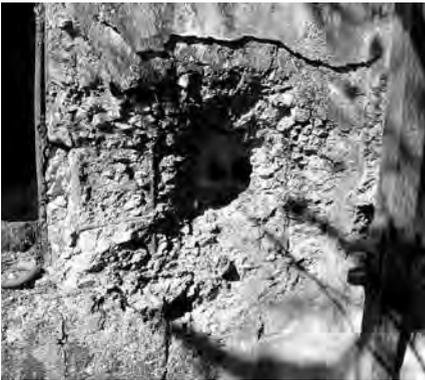
Fig 5: Penetrating hit mark on exterior of PB20's searchlight shelter on Hong Kong Island.

D: that the damage was rather minor compared to the penetration of the (thinner) wall of the search light shelter of PB20 as shown in **Figure 5**.

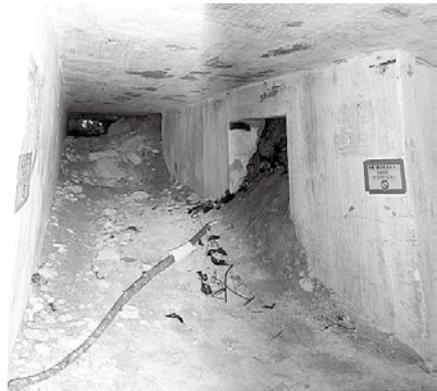
Figure 2: Entrance to the Telephone Exchange/Platoon HQ/Regent Palace Hotel in a tunnel.

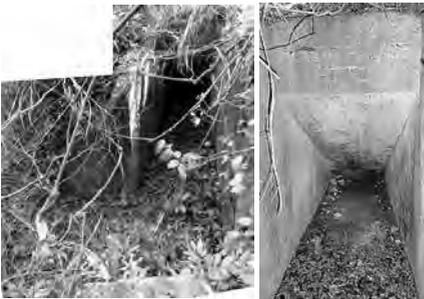
Figures 4A and 4B show the views of a tunnel entrance with the name “Regent Palace Hotel marked on the top”.

The name, “Regent Palace Hotel,” is marked on the outside of the tunnel entrance. Unlike other tunnels that have street names, this entrance is named after a hotel in London (**Figure**

1), which suggests that there was an underground structure inside with some sort of accommodation. A lot of concrete debris found in the area indicated that the structure was probably destroyed. The remains of the structure have also been completely covered by mud and rubble, possibly from a collapsed roof or an unknown opening.

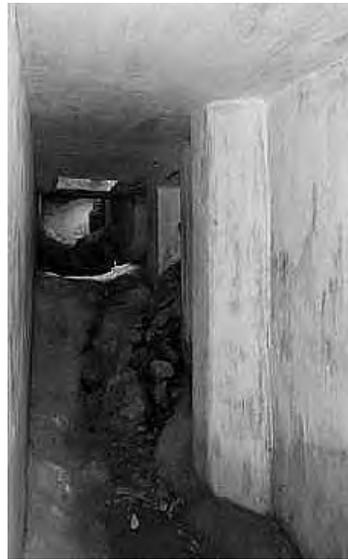
Figure 5: Bulge and opening along the tunnel wall in Shaftesbury Avenue. Note: The tunnel to Oxford Street is on the right side below the air vent opening.

A bulge and opening can be found along the tunnel wall in Shaftesbury Avenue. (**Figure 5**) The mirror image structure on the other side of Shaftesbury Avenue is separated by the tunnel branch.

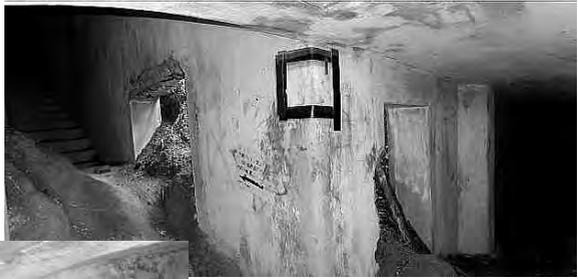
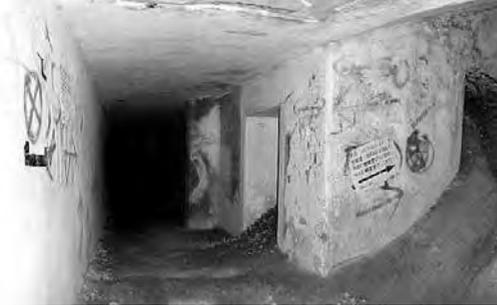
Figure 7: The mirror image structure on the other side of Shaftesbury Avenue as separated by the tunnel branch. Note: The right side is the tunnel branch to Oxford Street.

(Figure 7) Figures 8 and 9 show some details of the entrance to this tunnel. Outside the tunnel (Figure 8), one can find a hole covered by a landslide. A close check found two walls that extended from the tunnel wall and formed a closed square space around the tunnel corner. Concrete remains on top of the walls indicate a roof that had been located there. The remains indicated two underground concrete chambers that were originally built outside the tunnel on both sides of the corner. These underground structures were connected to the tunnel and may be similar to the construction around the previous Telephone Exchange/Platoon HQ/Regent Place Hotel location. The tunnel walls around the structure were 30cm thick. However, the redoubt's tunnel walls were normally 20cm thick. This indicated that both rooms were better protected than the rest of the redoubt. Building two structures separated by a tunnel also reduced the risk of destruction by a single hit.

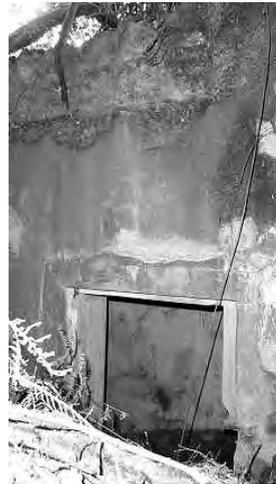
Figure 9: The entrance to the tunnel. Note: Note the damaged part on top of the wall indicating where a steel rebar inside the wall was removed.

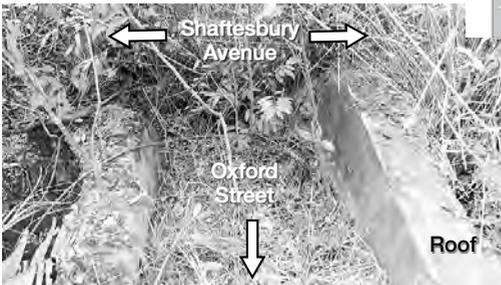
Figure 12: Looking from top of Oxford Street show the left and right side of the roofless structure. The top line of original roof is still visible.

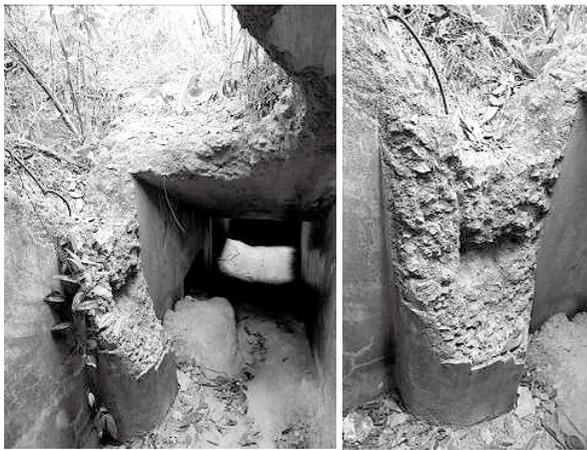
Figures 15A and 15B: The damaged bulge along the tunnel wall of Structure Y. Note the hole in the middle used to support the end of the steel rebar of the ceiling support beam.

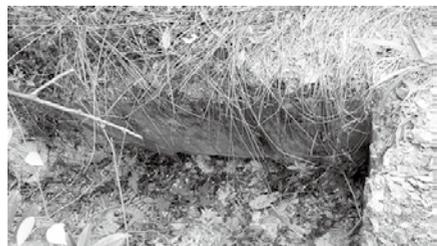
Figure 17: The shelter is almost completely filled by mud.

The shelter is almost completely filled with mud (**Figure 17**). Only some of the wall above the entry opening is exposed. Just as with Structure X, the roof has been removed. The other side of Structure Y still retains three sides of its wall. The missing side wall is covered by earth. (**Figure 18**)

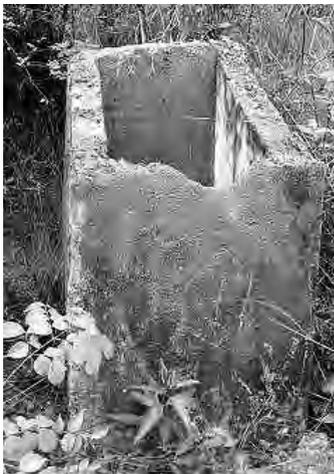
Figure 19: Ventilation shaft near Structures X and Y.

There is a ventilation duct at about the tunnel junction between the two shelters. (**Figure 19**) The top of the duct was damaged, where a metal cover might have been installed for protection. Some sources mention that soldiers could seal the ventilation duct from inside the tunnel when under attack.

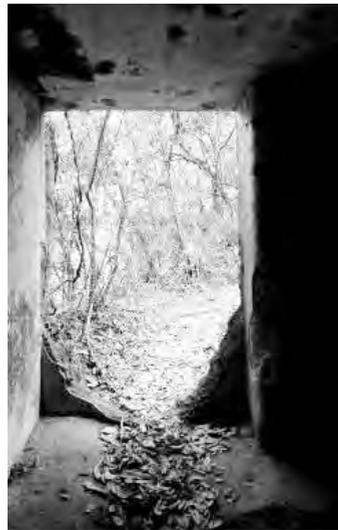
Figure 21: The emergency exit (?) from the inside.

On the route towards PB400 from Structure Y is an opening along the tunnel wall. The lower half of the opening is blocked by a concrete wall. This might have been an emergency exit for the tunnel (**Figures 21 and 22**). The upper section might have been covered so it could not be seen from the outside. Anyone could open it from the inside when needing to exit.

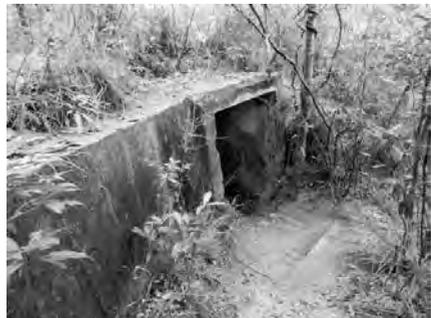
Figure 22: The emergency exit (?) on the outside.

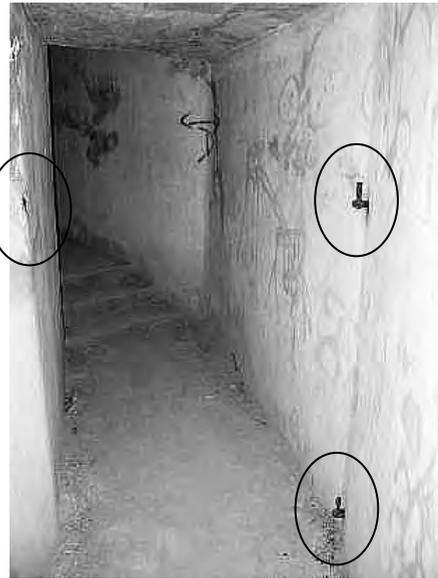
Figure 23: the Gate to PB400.

Going farther into the tunnel and passing the spur to PB400, one will see two metal gate hinge pins set into the wall. (**Figure 23**) A hole for a securing bolt is located on the other side of the wall. This indicates the presence of a gate in the past.

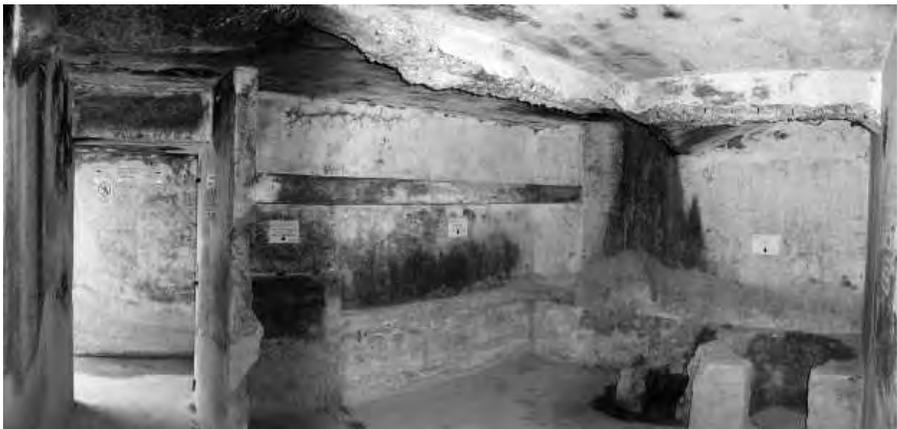
Figure 24: View of a kitchen of the popularly known Strand Palace Hotel.

The headquarters were below the Artillery Observation Post (OP). It had two underground rooms with the same layout. The presence of structures to hold cooking ranges, a water tank, and storage racks (**Figures 24 and 25**)

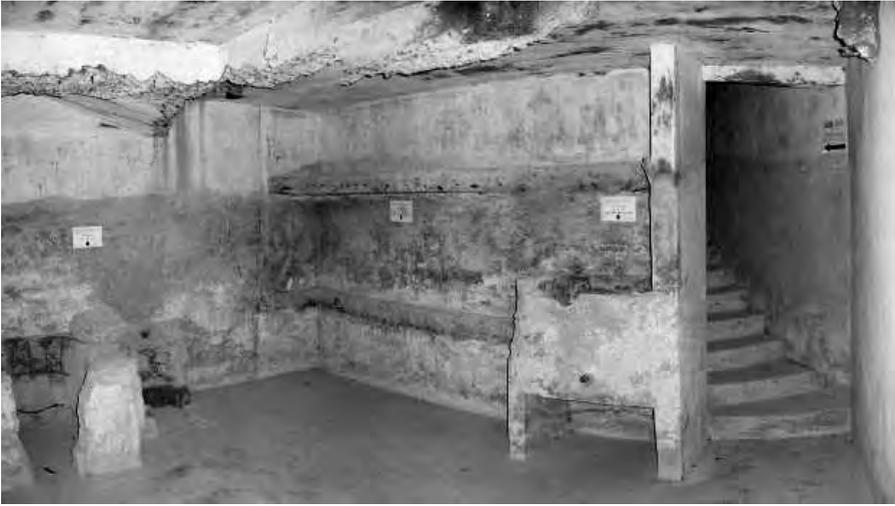
Figure 25: View of another kitchen of what is popularly (and perhaps mistakenly) known as the Strand Palace Hotel: the steps lead up to the Artillery Observation Post.

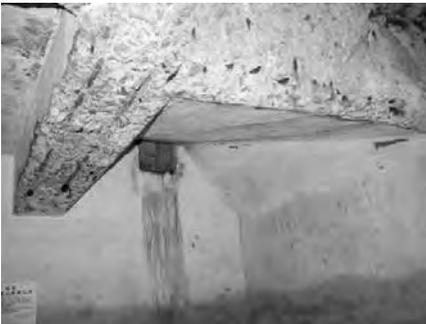
Figure 26: Roof of a kitchen in the “Strand Palace Hotel”.

Damage to the roof's supporting column shows that the rebar inside was removed (**Figure 26**). The imprint on the damaged concrete indicates where the two thick rebars were previously located. The remains of the steel rebar are still visible at the end of the column. It was too difficult to dig them out, so the exposed rebar was cut away leaving the remainder in place.

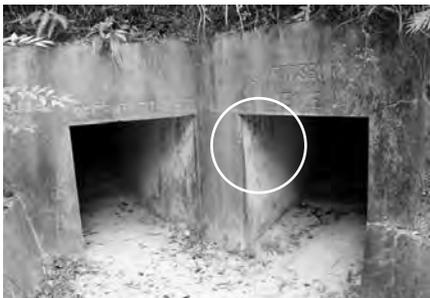
Figure 27: “TO O.P./STRAND PALACE HOTEL”.

The “kitchen” below the OP is called the Strand Palace Hotel by many references on the redoubt. However, I have not seen any British record that called this structure the Strand Palace Hotel. Map 3 of the Cabinet Report (Latham 1958) puts a question mark after “OP/Hotel” in this place. The only place within the redoubt where the name was visible is at the entrance to Shaftesbury Avenue from the open firing bay. The text, “**TO O.P./STRAND PALACE HOTEL,**” is engraved at the tunnel entrance wall (along Trench “T7” in **Lai et al 2011**) (**Figures 27 and 28**) and the arrow below points in the OP's direction. This may also be why people have taken the “kitchen” area to be the Strand Palace Hotel, as the name was placed with the OP. Following the tunnel from

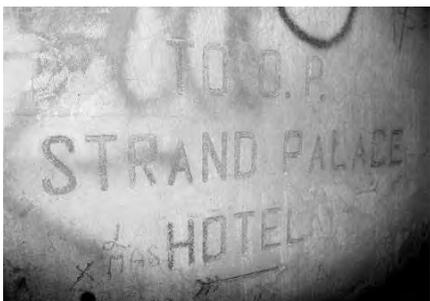
Figure 28: The engraving inside Shaftesbury Avenue near its entrance as seen in Figure 27 above: “TO O.P./STRAND PALACE HOTEL”.

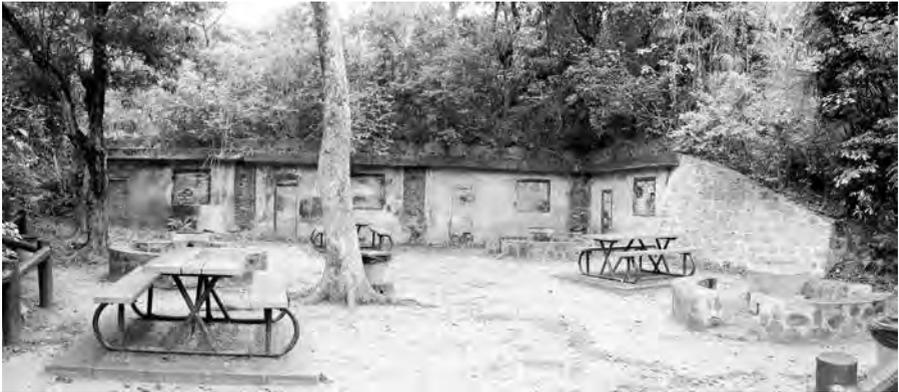
Figure 31: Four ‘A’ Type Splinter Proof Shelters at Tai Tam Tuk Reservoir. This is possibly a location of company headquarters in the wartime.
