Research Report

The Land Surveying Division

**Pattern Recognition on Cultivation and Natural
Vegetation**

Dr Conrad Tang LSGI, HKPolyU

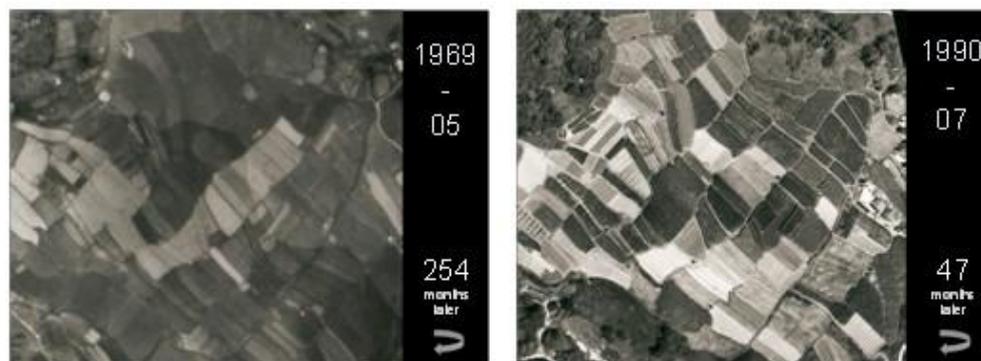
Figure 1 Aerial photos in 1969 & 1990

Although blurred images were on the 1969 aerial photograph, it was perceptible those were land under cultivation. In 1990 aerial photo, the field boundaries were clear, the lands were under active agricultural activities (Figure 1). The continuous pattern of agricultural activities witnesses land use changes.

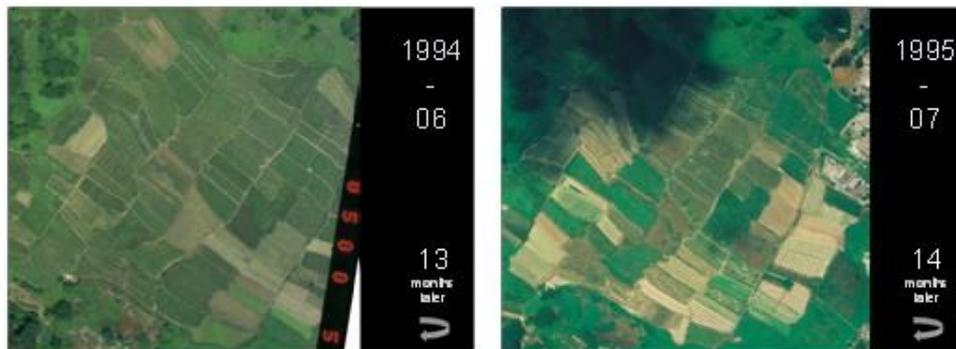
Figure 2 Aerial photos in 1994 & 1995

In the 1994 aerial photo, the field boundaries were not very clear. The tone of the picture was gray. Some white postharvest fields without grasses are found. Dark green patches may represent crops or abandoned overgrowth. In the 1995 aerial photo, the textural and boundary of fields were clear. The fields were under cropping. (Figure 2)

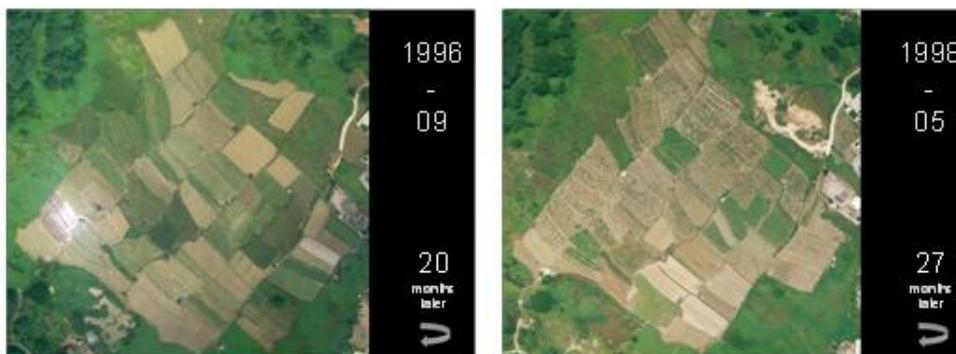
Figure 3 Aerial photos in 1996 & 1998

In the 1996 aerial photo, the textural and boundaries of fields were clear, the lands were under cropping. In the 1998 aerial photo, fields at north-west were grass lands. Postharvest fields with grasses could be abandoned fields. Some fields at the south were under cropping. (Figure 3)

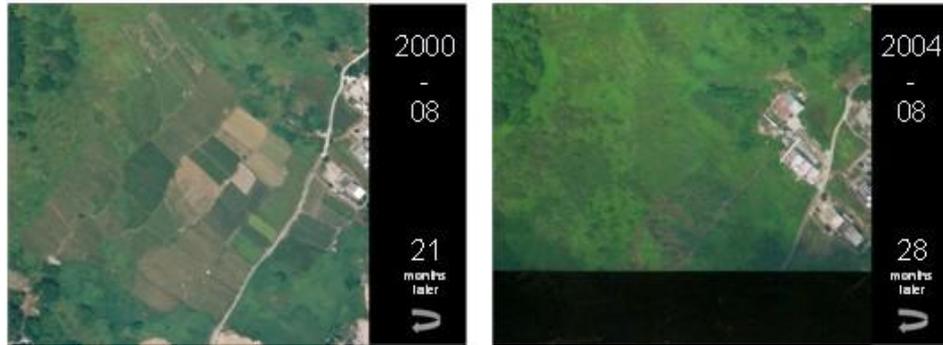
Figure 4 Aerial photos in 2000 & 2004

In the 2000 aerial photo, most of the postharvest fields with grasses were abandoned. Only some fields in the middle without grass were under cropping. There is a new road appeared at the east side of the picture. In the 2004 aerial photo, the area was covered by wasteland of lush green overgrowths. The change of patterns tells the story. (Figure 4)

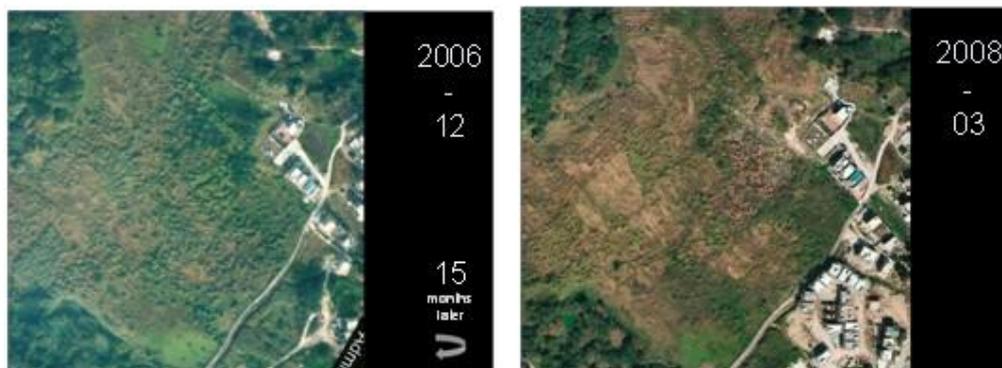
Figure 5 Aerial photos in 2006 & 2008

In the 2006 aerial photo, large patch of bushes are found. In the 2008 aerial photo, some patches of land were cleared with vegetation. It is envisaged that bushes were burned down.

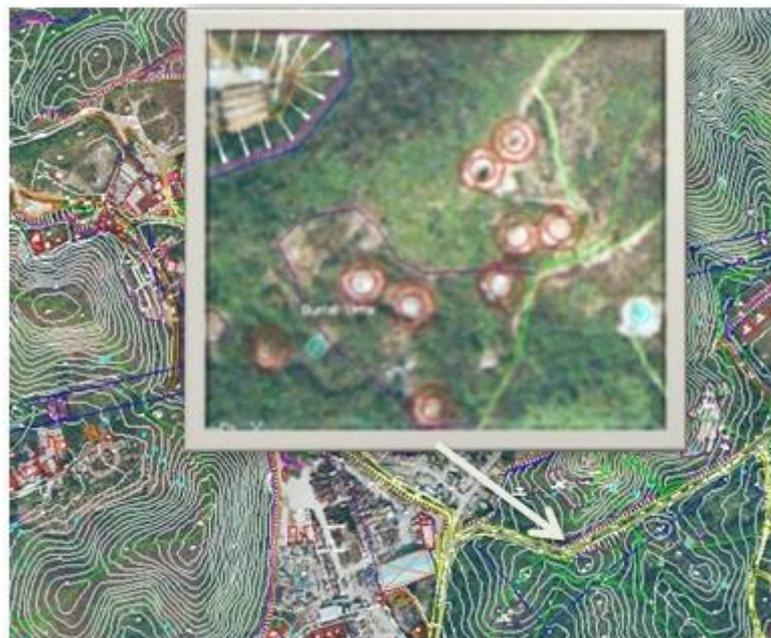
Figure 6 Graves on the orthophoto and survey sheet.

The background picture is the current orthophoto. The lines are the B1000 survey sheet. There are only 2 graves shown on the survey sheet (blue circles). Comparing with the current orthophoto, there are about 10 graves in this area. New graves are marked in red circles on survey sheet. Surveyors then run the field check and take site photos for record.

Using the current aerial photographs to update 1:1000 survey sheets is a fast and convenient method to keep the survey sheets advance with the time. Furthermore, using the current survey sheet to update land-use map can save fieldworks. Figure 6 shows the images of identifying graves by checking current orthophotos and marking new land uses on topographic maps.

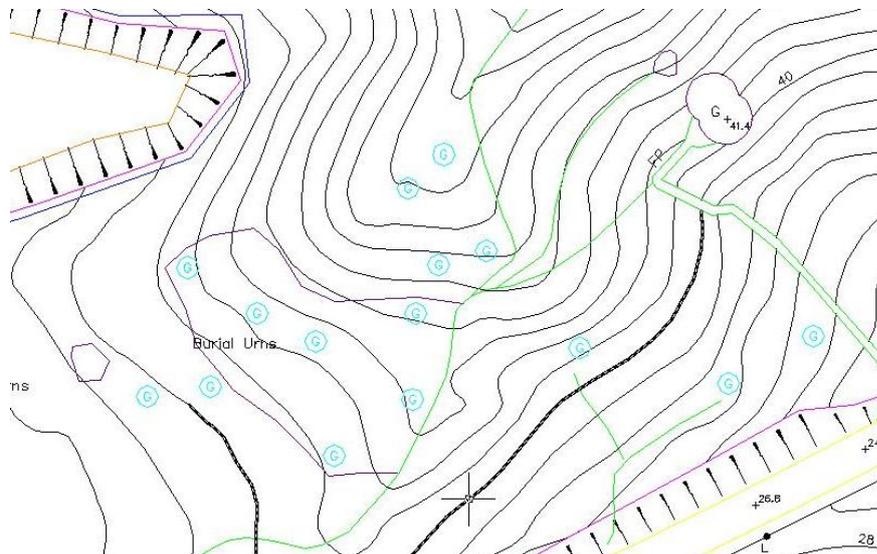
Figure 8 Updated survey sheet.

Checked new graves were drawn on the survey sheet in blue circles.(Figure 8)

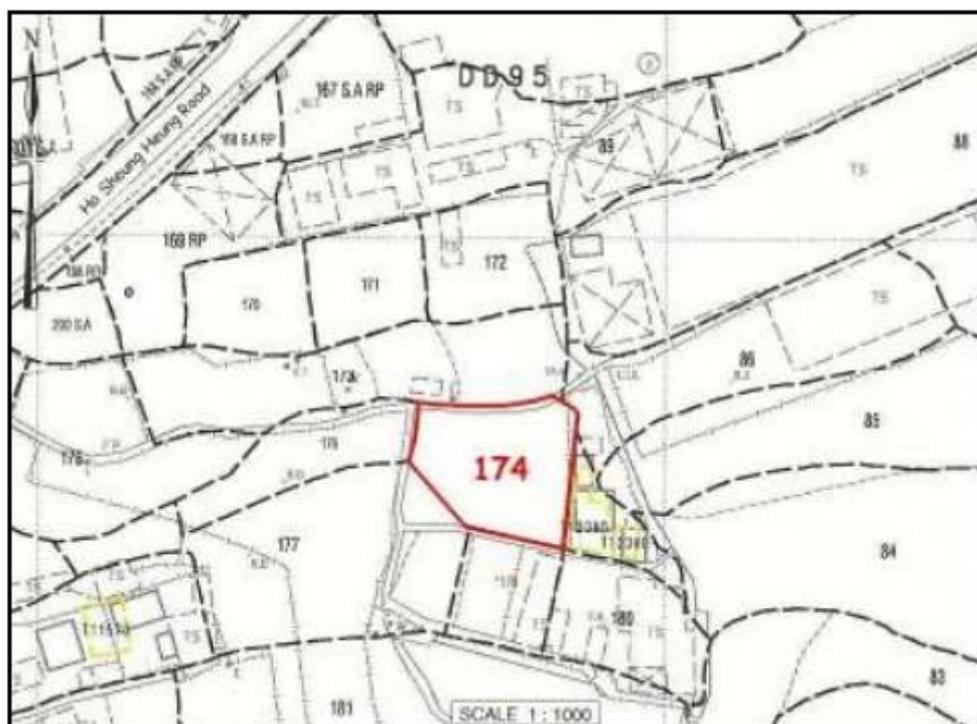
Figure 9 Part of LIP showing the subject lot (Ref No. 153/2009)

The first case is heard in Court of First Instance of Hong Kong in December 2006. The subject lot in this case was Lot 174 in DD 95. It lies in the Kwu Tung area in the northern part of the New Territories.

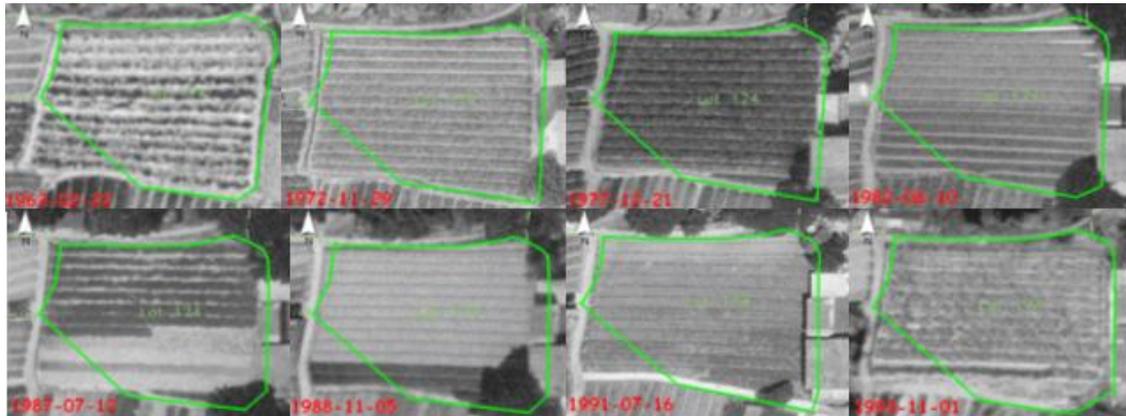
Figure 10 A set of enlarged aerial photographs from 1963 to 1993.

The following aerial photos show the lot farming from 1963 – 1995.

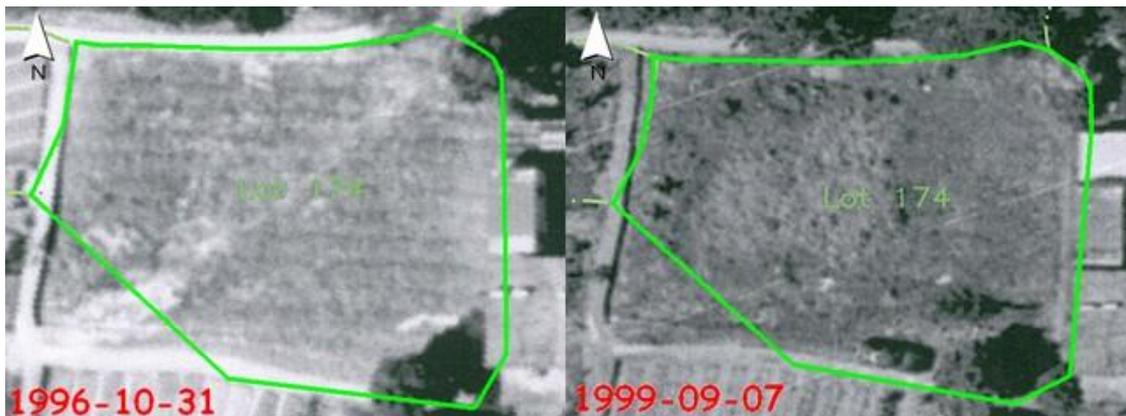
Figure 11 Part of enlarged aerial photograph in 1996 and 1999.

In 1996, the lot was illegibility of row crops and in 1999, the lot was overgrown vegetation.

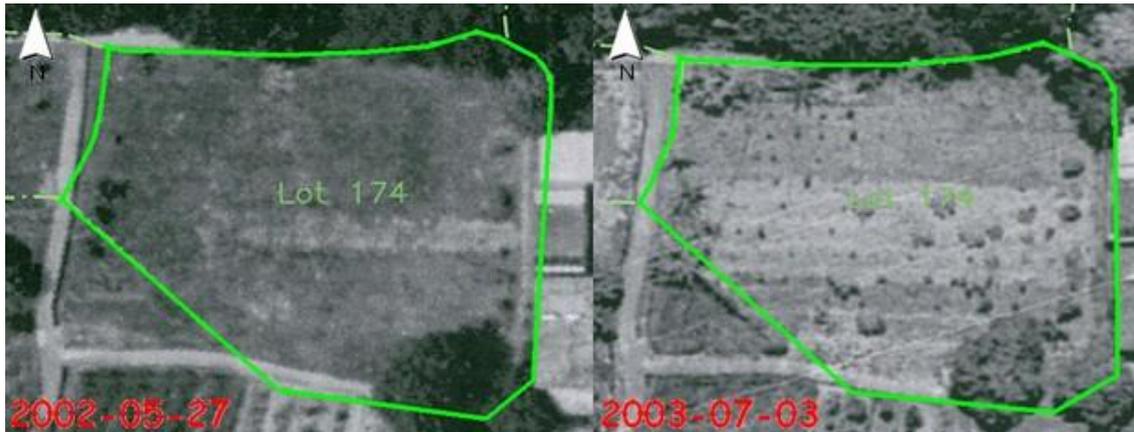
Figure 12 Part of enlarged aerial photograph in 2002 and 2003.

In 2002, the pattern shown deserted bare ground. In 2003, the lot was overgrown with isolated bushes.

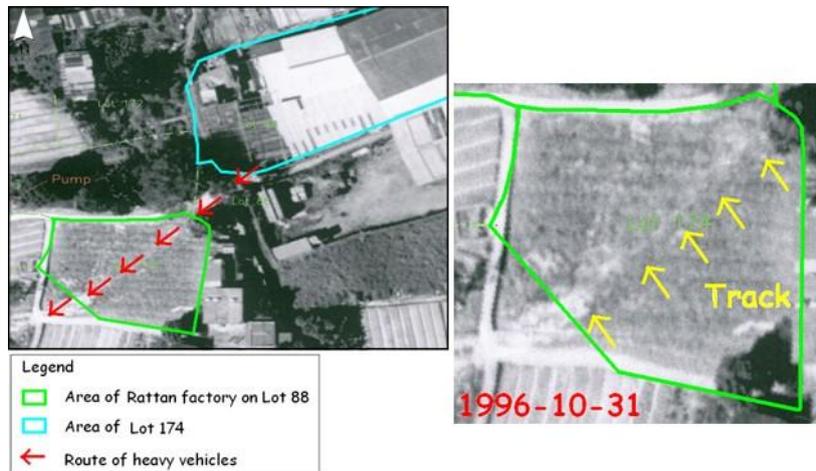
Figure 13 The Track on the aerial photo.

One disputed incident was on the existence of a track which was evidenced here with the aerial photos. The plaintiffs gave permission to adjacent owners to remove heavy machinery in 1996. Defendants considered that the action had no entry onto the subject lot. Figure 13 showed track visible on the aerial photos there the surveyor experts had agreed that the track was the result of dragging of heavy objects.

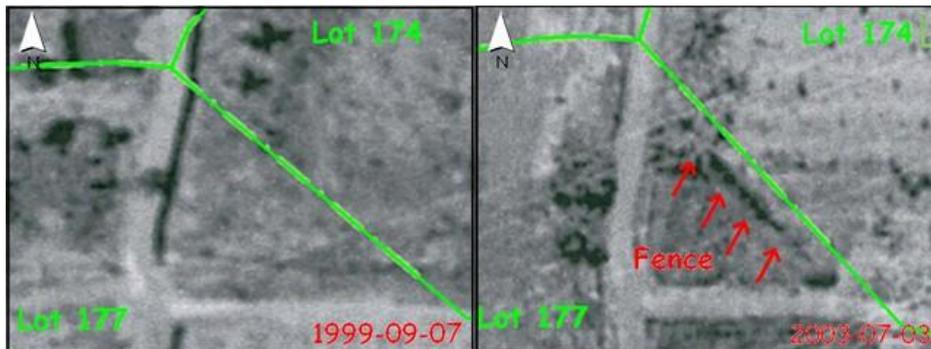
Figure 15 (Left and Right) Part of enlarged aerial photograph in 2002 and 2003 showing the subject lot and Lot 177.

In Figure 14, it was shown that Lot 177 was fenced off. The owner claimed that it was done in 2002. Plaintiffs presented the survey plan evidence to show no encroachment upon the subject lot was made. One surveyor expert even claimed that the Wire-Fence in 2002 and 2003 were visible.(Figure 15)

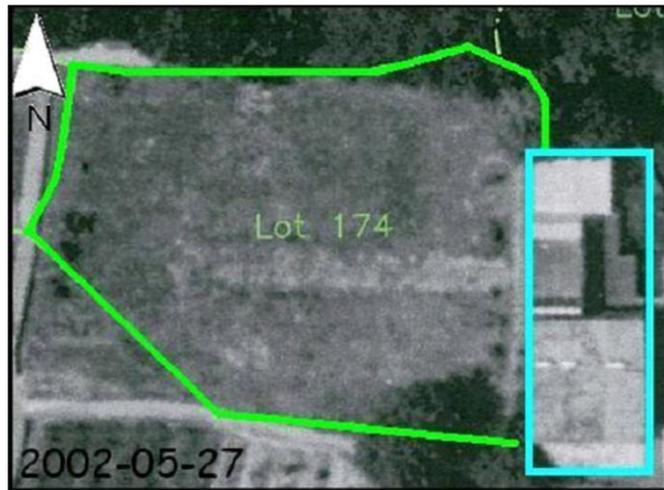
Figure 17 Part of enlarged aerial photograph in 2002.

Figure 17 showed that there was basically vacant land in the Lot 174 in year 2002.

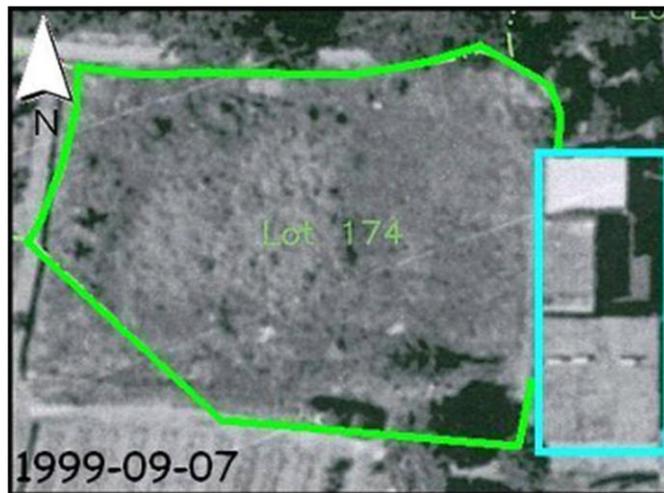
Figure 18 Part of enlarged aerial photograph in 1999.

The plaintiff claimed that the grass was cut once only. Figure 18 showed the result of grass cut in front of defendant's house.

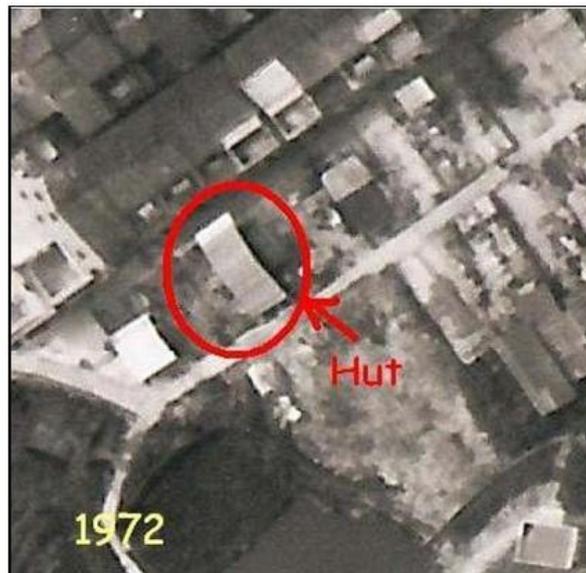
Figure 20 Enlarge aerial photograph in 1972 showing the hut
Year of 1980, 1996, 2003

Since the defendant's grandparent's time, his family has been residing for years at a one-story house. The house no. is 31. In about 1972, the defendant claimed that his father built the hut opposite the old house across the footpath. At that time, the land was still undeveloped and no house was built on the lot. In the aerial photograph in 1972, we could find the hut.

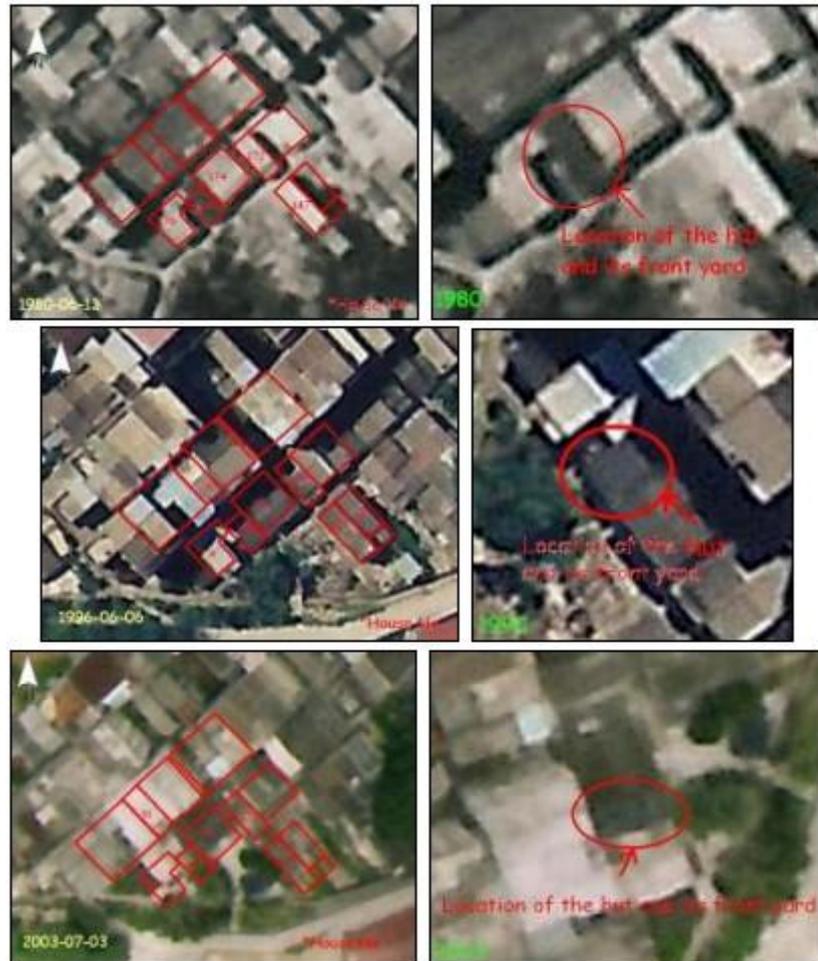
Figure 21 Enlarged aerial photographs in 1980, 1996 and 2003 showing the hut.

In these three aerial photographs, the hut was still erected. Geo-referencing was performed to find out the location of the hut by this project team. They were the same location even their images on different years varied. (Figure 21)

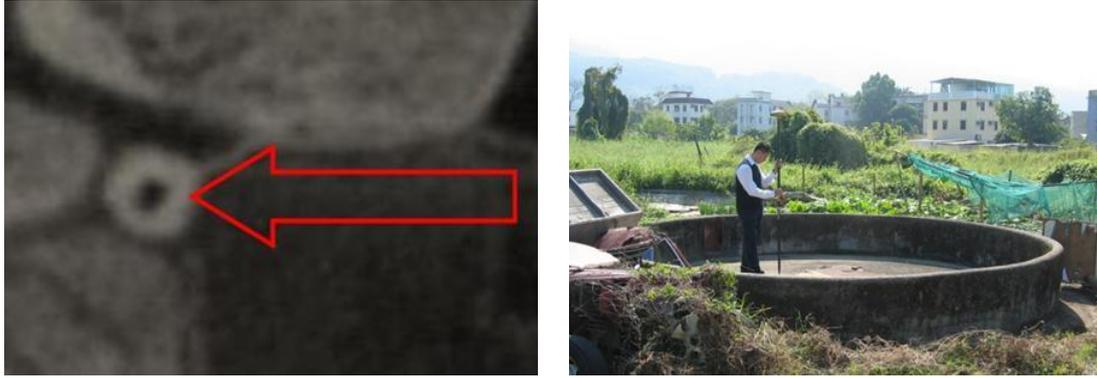
Figure 23 A well on 1949 aerial photograph and its current view.

- a) Find out the existing points displayed on the aerial photo in 1949.
- b) Measure the coordinates of these points by GPS.

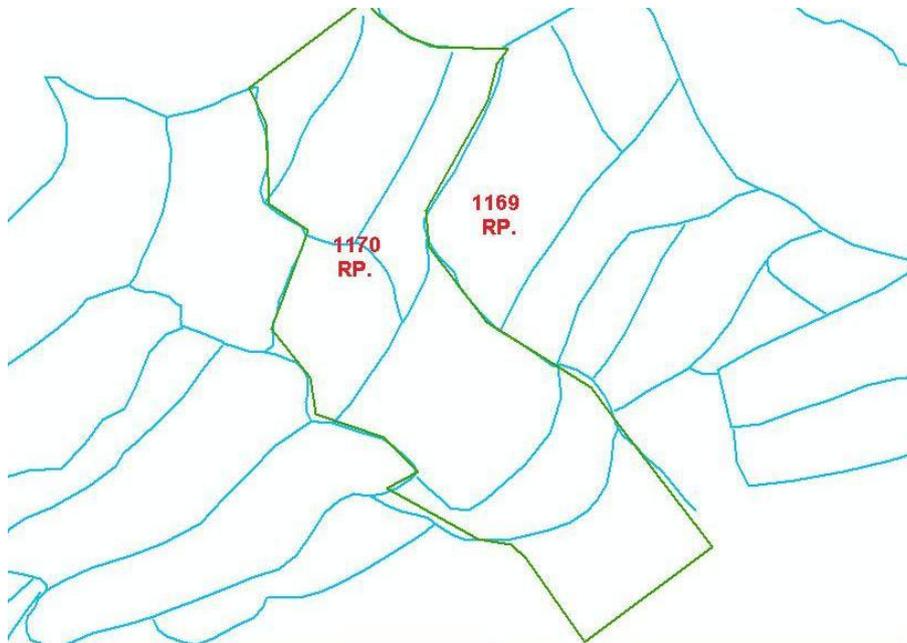
Figure 24 The final result.

The blue line was the boundary of 1949. The green line was the link of the survey points in 1989. As shown by the picture, the boundary showed no obvious change between 1949 and 1989. As seen from Figure 24, the 1949 field bunds (lines in blue) and the Lot boundaries on the 1985 SRP (lines in red) were geo-referenced. The subject boundary was found within 1 to 2 meters. The encroachment of a strip of land for 3 meters could not be proved.
